Here are some Heathkit VHF-1 (Seneca) problem solutions and modifications. I had the good fortune to acquire a Seneca that was originally well built and remained relatively unmolested. The arrangement of items below is in their approximate order of encounter in proceeding through the Testing, Adjustment and Calibration Instructions section of the Heathkit Assembly Manual. With these changes, I have added no new holes, nor done anything else that is irreversible.

Bob
NA7RH 3-18-2009

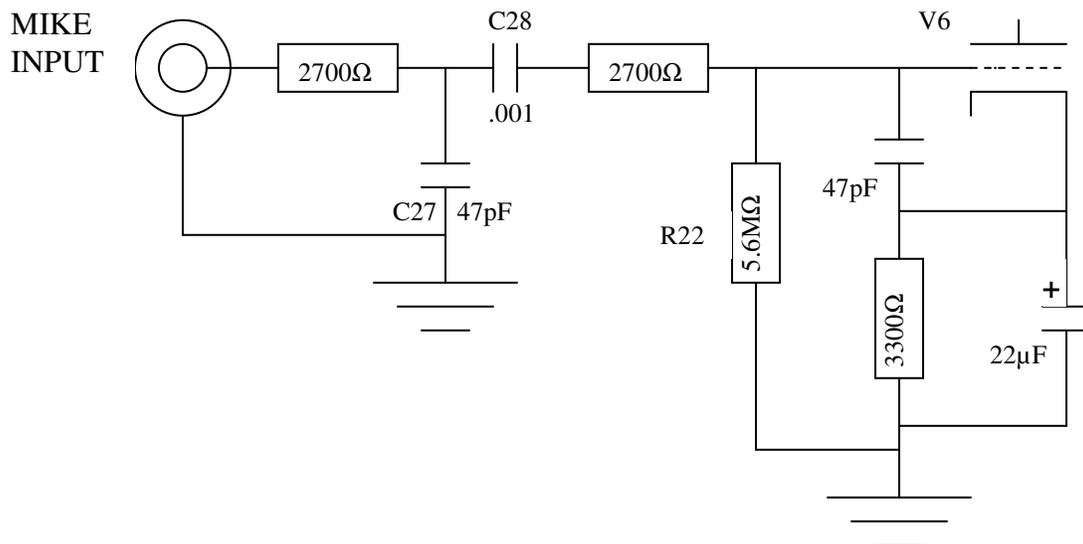
At the mike input, the long leads to ground of the 100pF bypass capacitor (C27), shown in Seneca Assembly Manual Pictorial 14, coupled with the low RF impedance through coupling capacitor (C28) to the first grid, do not provide much RF attenuation at 2-meters. The 2-meter RF attenuation is insufficient when the mike cable length resonates near the transmit frequency, and perhaps for a wide range of lengths.

Another concern about the mike input circuit is the load presented to a crystal microphone. For a crystal microphone on AM phone, a 1 meg ohm resistor (R21) in parallel with 2.2 meg (R22) is normally too low a load impedance for the desired low frequency response.

Corrective Action for RF Sensitivity & Mike loading:

The first 2700-ohm resistor mounts inside the MIC connector, soldered into the center contact. C27 goes directly from the protruding lead of that resistor to the MIC connector ground lug. The input 1 meg ohm resistor to ground, R21, was removed, but could have been replaced with a 10M ohm resistor. The other 47pF capacitor connects between V6 grid and cathode, soldered to tube socket terminals 7 and 8. On cathode terminal 8 of V6, be certain to disconnect the short wire to ground. Addition of a solder lug under a V6 tube socket mounting screw provided a ground for the added cathode resistor and its bypass capacitor.

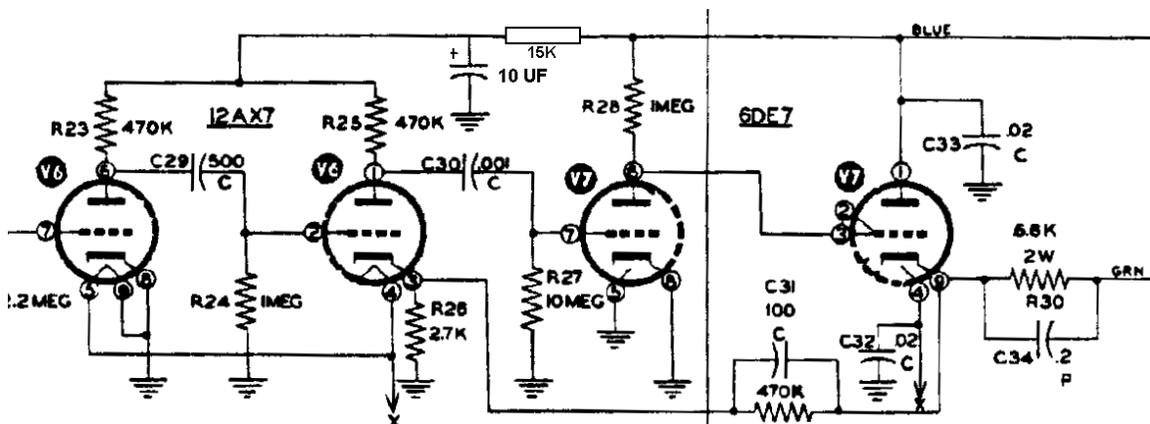
Figure 1, Speech Amp with added Supply Filter

Continuing testing with the mike input loaded with 75 ohms, the remaining hum now had a 120 Hz rectified AC waveform and the level produced about 10 percent modulation. With that load swamping the input, the most likely cause of the hum was inadequate supply filtering. That should come as no surprise after study of the schematic. A triode audio preamplifier stage, of itself, has very little power supply rejection. In this speech amp, we do not see the usual B+ supply R-C filter section that would reduce ripple to the first stage and suppress audio feedback from later stages. In fact, in the VHF-1 300V

supply, there is only one 40 μ F electrolytic capacitor (C43) for ripple and audio frequency filtering. After 50 years, that electrolytic capacitor could be degraded; however, the ripple on the 300V supply measured about as expected, given the 6H choke and 40 μ F capacitor.

Add a 300V supply line filter for the 12AX7 speech amplifier stages of V6, with the following steps. See the schematic below.

Remove the orange hookup wire between lug 2 (B+ to V6) and lug 4 (B+ to V7) of terminal strip AA. Replace wire with a 15k ohm resistor between lug 2 and lug 4. Install a 10 μ F, 450v electrolytic capacitor between lug 2 of terminal strip AA and ground (I used V6 terminal 9 for ground, with sleeved leads, positioning capacitor against chassis). Actually, any capacitor value greater than 2.2 μ F should attenuate 120 Hz ripple by >26 dB, reducing hum modulation from 10 percent to less than 1 percent. Install a new 0.2 or 0.22 μ F, \geq 200v Polypropylene or Polyester Capacitor for C34.

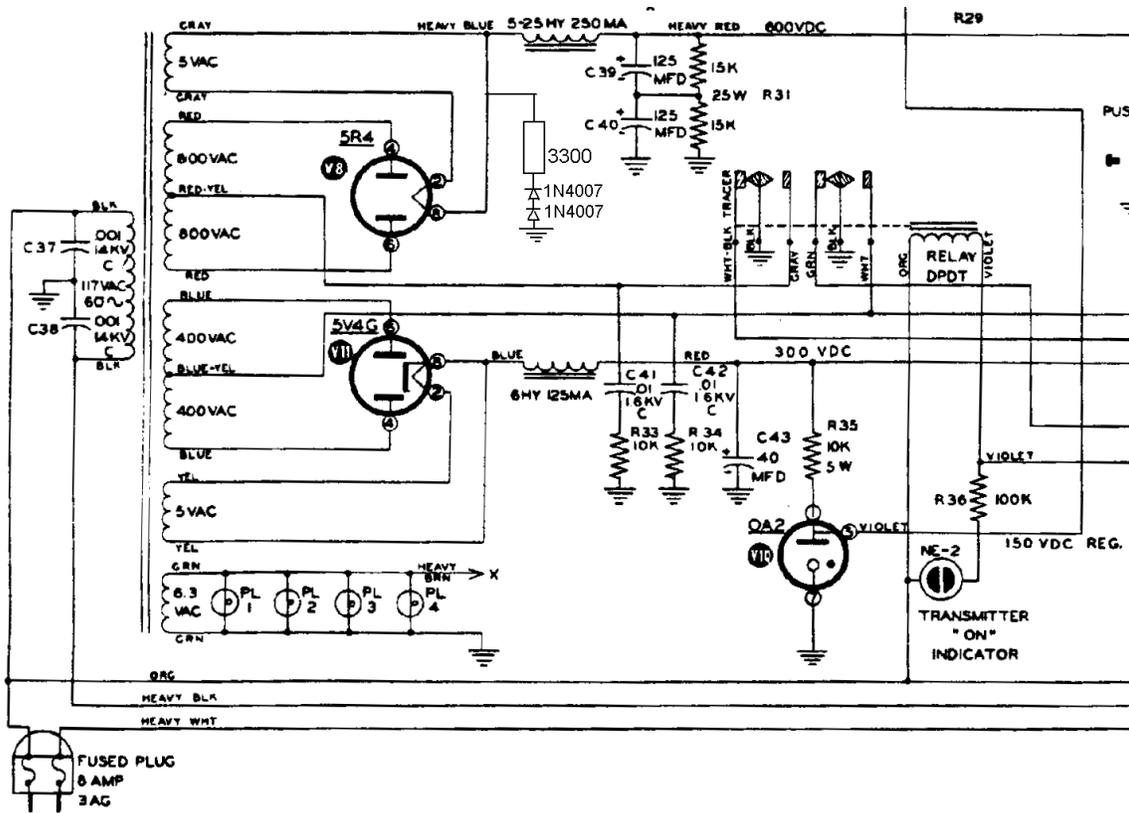
Figure 2 , VHF-1 Power Supply showing Fly-back Damper

To remove high voltage for Standby, relay contacts open between ground and the center tap of the power transformer high voltage secondary. The under-damped choke input filter of the HV power supply generates a high voltage fly-back and a relay contact arc when switching to Standby. At first, that arc ignited some excess flux on the relay terminals, producing glowing embers and smoke. With the flux removed, the arc became an often-loud audible snap or pop. C41 and R33 (see the schematic below) were obviously intended to do some damping; however, even with low current (100 ma including bleeder, when un-modulated or CW key-up) in the swinging choke there is enough energy stored in the choke (>0.1 joule) to charge the 0.01 μ F capacitor to about 4500 volts, ignoring choke losses. The capacitor would need to be increased to 0.2 μ F or more, to limit the potential capacitor voltage to 1000 volts (and the voltage across the 10k resistor in series could be an additional 1000 volts).

Solution: Install another terminal strip on the same screw as terminal strip BB in Pictorial 18. On the terminal strip, install a damping network consisting of a 3300-ohm 2-watt flameproof metal film resistor and two 1N4007 rectifiers, all in series with anodes toward ground. The ungrounded end of the network, wired to terminal strip DD lug 5, connects to the rectifier end of the 5-25 H swinging choke and to the 5R4 cathode. The normally reverse biased network absorbs the negative going transient when the relay contacts open. In the event of double diode failure, the 3300-ohm resistor should be large enough to protect the irreplaceable transformer.

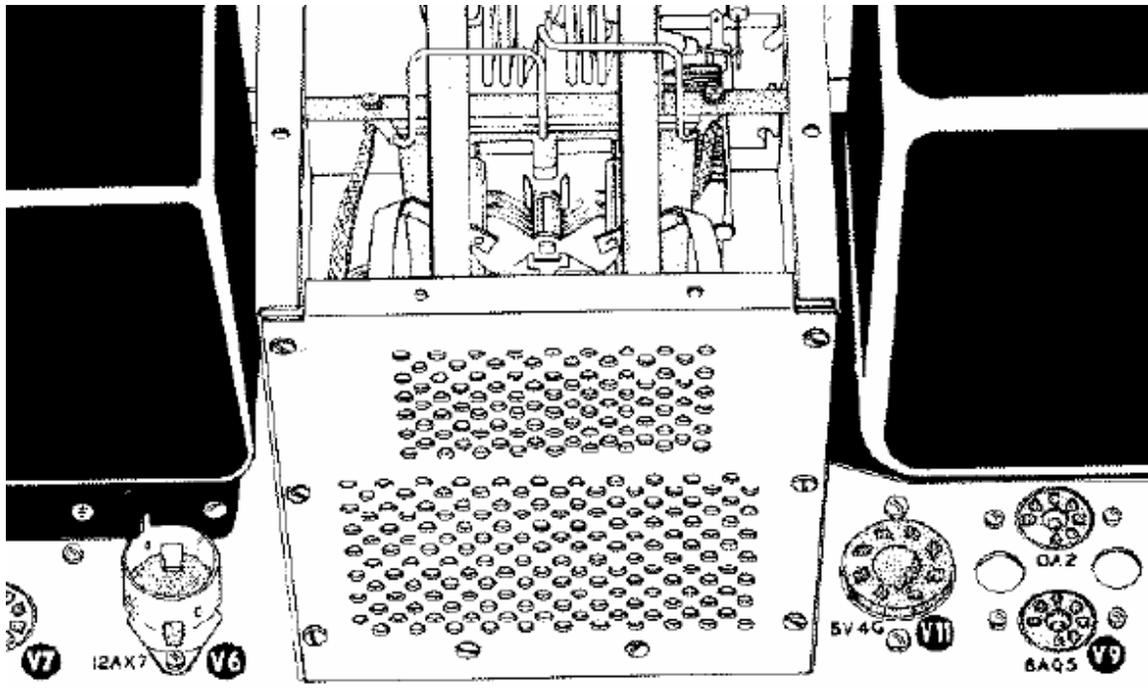
Figure 3, Part of Pictorial 32 showing Link Coupling Coil

The adjustable Link Coupling Coil at the Final output was installed upside down. The Finals would not load to more than 160 ma or produce more than 45 watts of CW output power on 2-meters. After five months of looking at the Seneca and its assembly manual, I finally observed in Pictorial 32 (page 78 and below) and Pictorial 13, that the pictured movable link coupling was different from my unit. The pictured link coupling wires, extending from the spade lugs mounted on the phenolic shaft, cross over the shaft, while in my unit the wires passed under the shaft. Was this actually an assembly error, or was it a method to obtain greater output loading with 6146Bs on 6-meters?

Solution: Install the Link Coupling Coil per Assembly Manual. The Finals will now load to more than 200 ma and produce more than 55 watts of CW output power on 2-meters with the AC line at 117 volts.
